THE SACRED GROVES

WOODLAND APPRAISAL - GIGGIN
PRYSG, RHAYADER, POWYS, MID
WALES - 11.8 ACRES

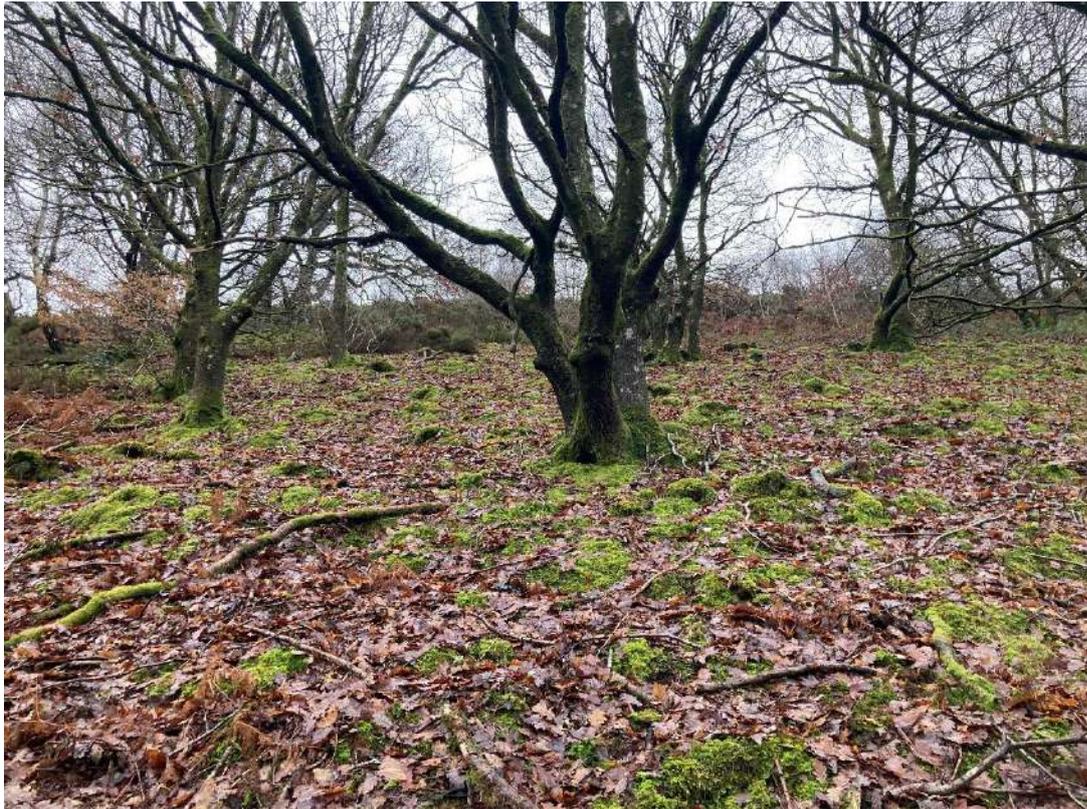
Mature tree in more open area on the higher slopes towards the eastern Boundary

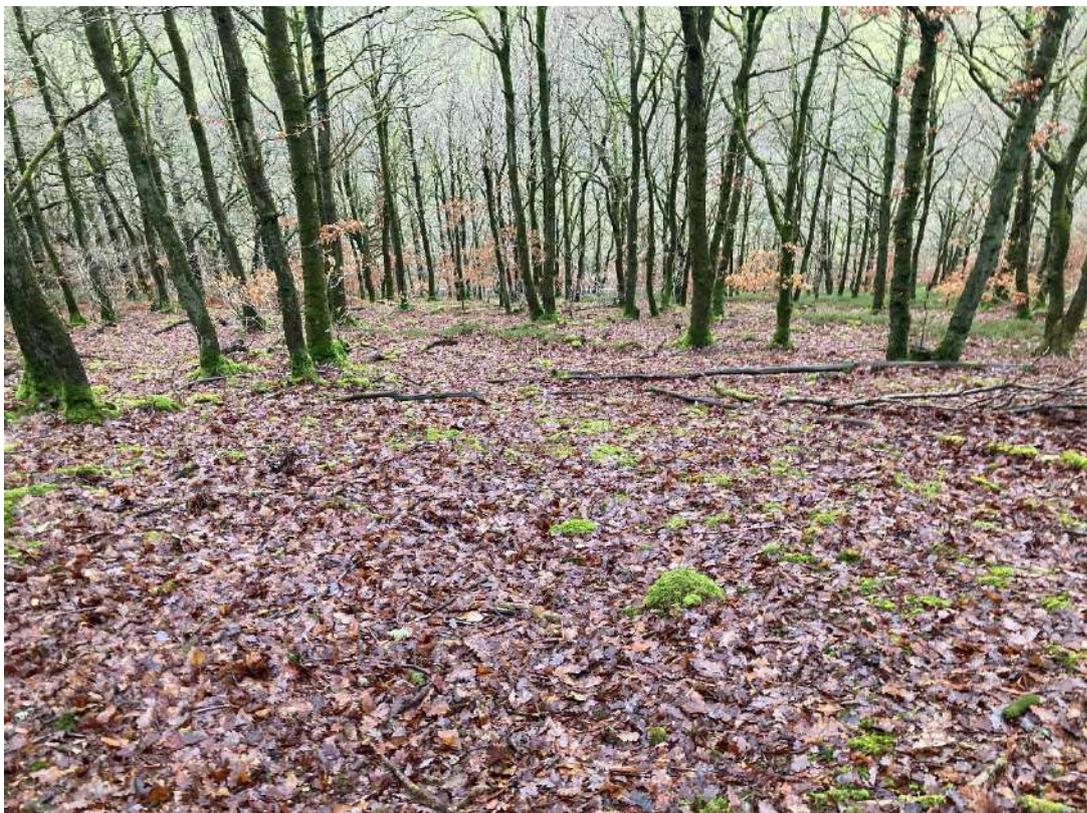
Oak High forest on the lower slopes

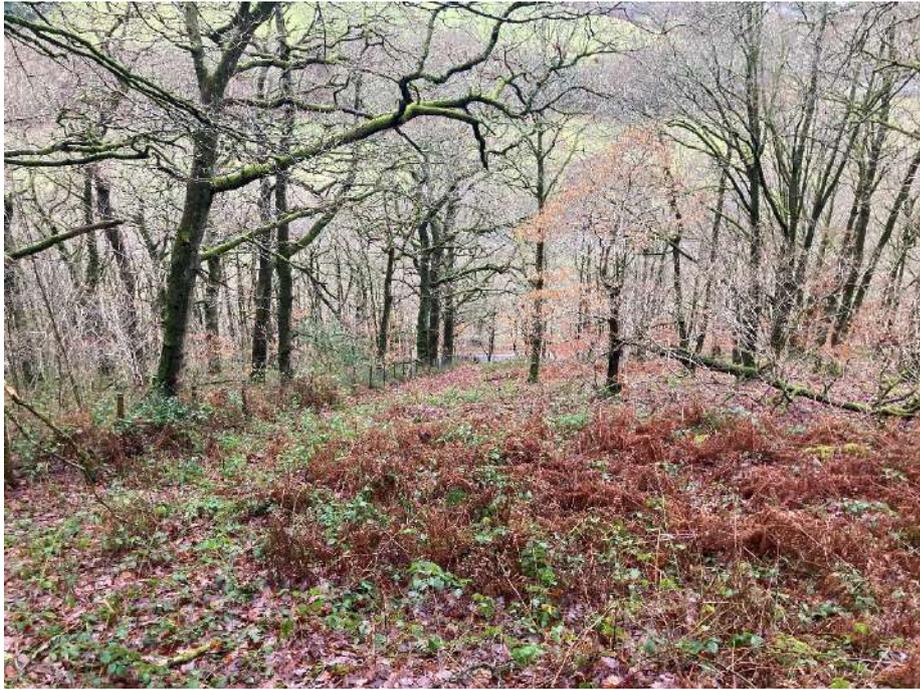
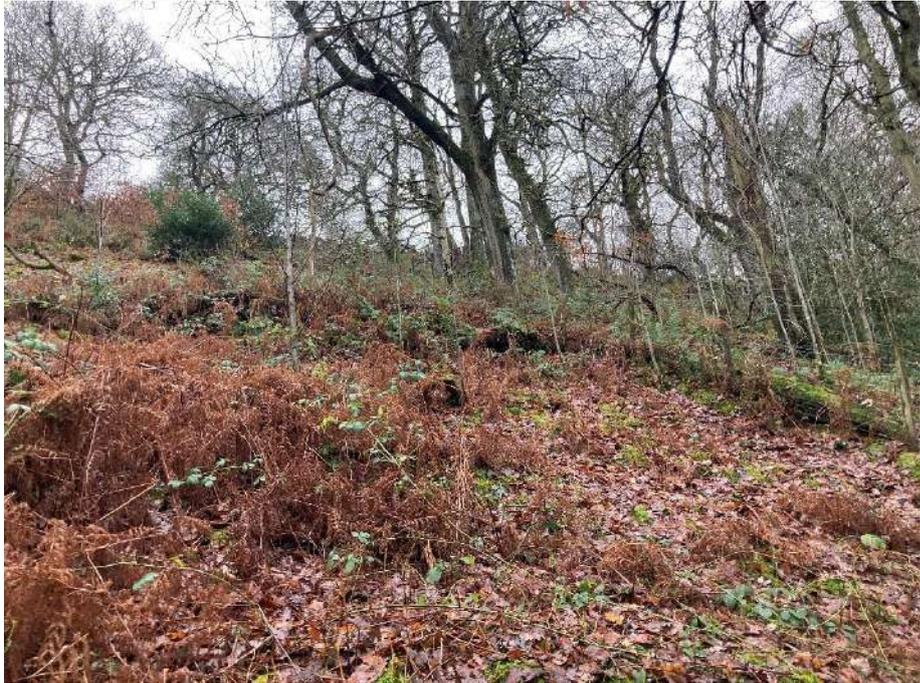
2.3.3 On the eastern boundary there are some open areas adjacent to the fence with occasional mature trees and some regeneration of birch and ash as well as some areas of bracken which may be preventing some regeneration in places.

Areas of bracken with some regeneration on the upper slopes

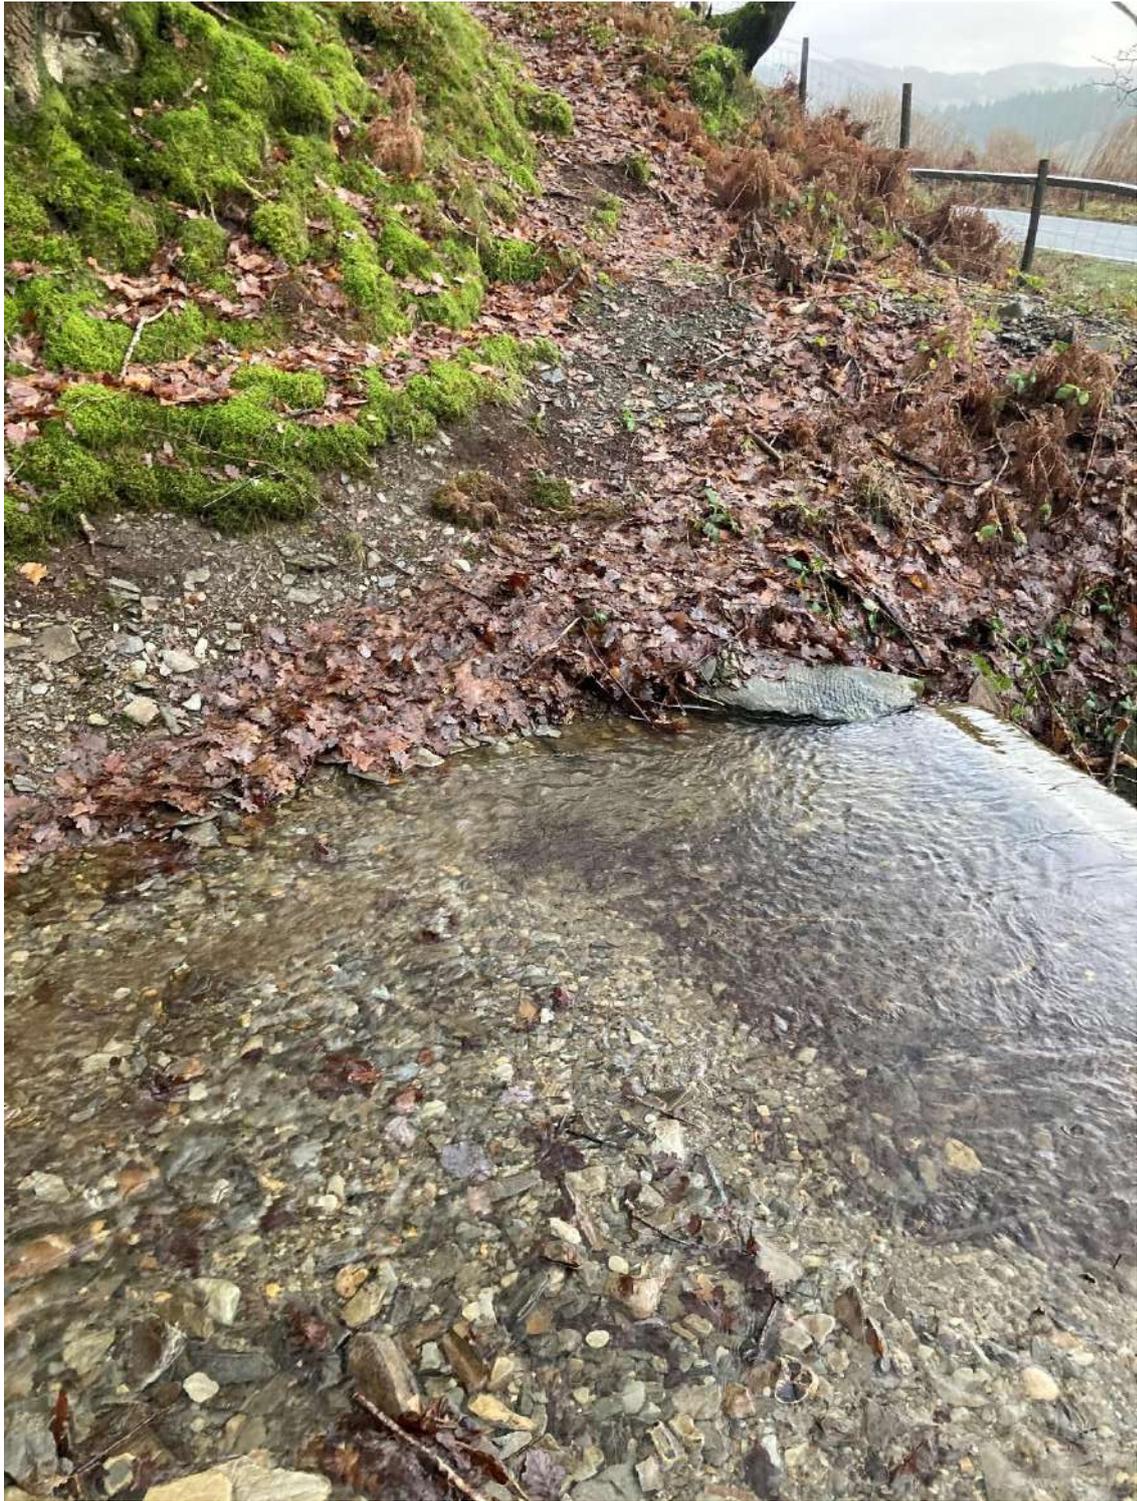
It appears that the access to the woodland is from a gate off a layby offsite which will allow vehicular access to the north western corner across the stream. Some stone has been dropped here, but there is no infrastructure in place to enter the woodland with forestry machinery and any woodland operations would need to be carried out with small-scale forestry machinery and motor manual chainsaw operator.

Current access across stream

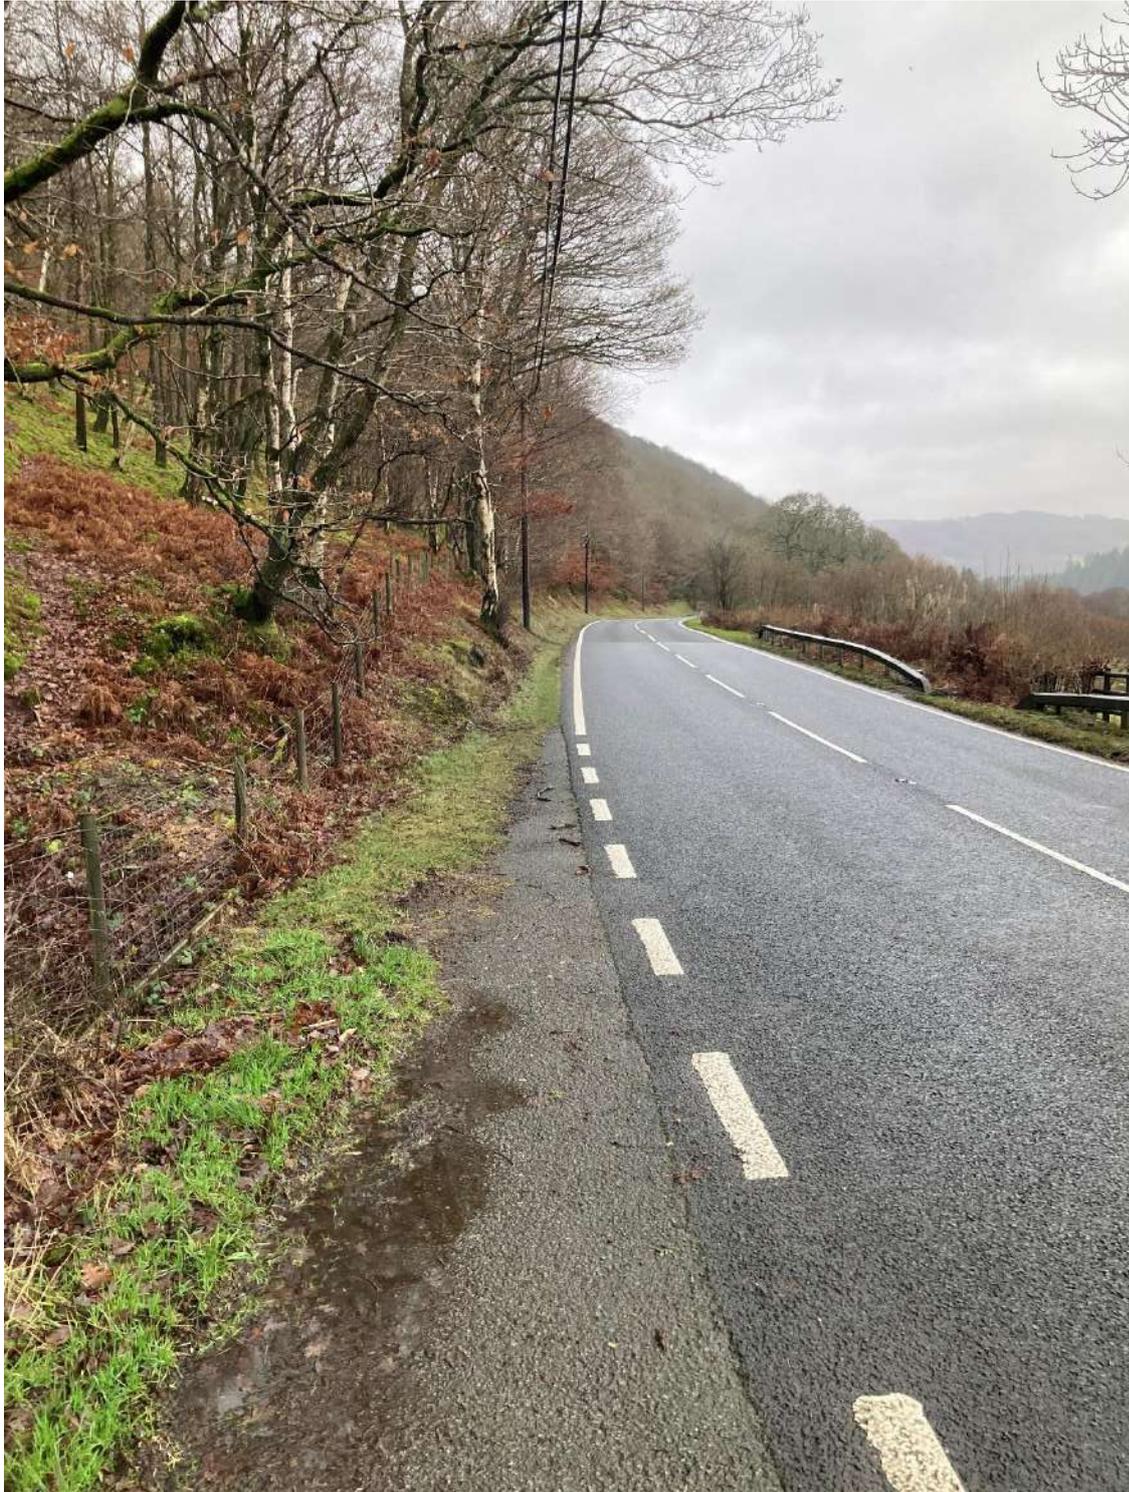
The woodland is adjacent to the A470 and as such there will be a liability for management of trees adjacent to the roads, there are no current issues, but it is suggested that the roadside trees are inspected within a year of purchase and any remedial works carried out to ensure the long-term mitigation of any risks which are small trees along the roadside.

A470 – view of a boundary, note boundary is the top of the verge

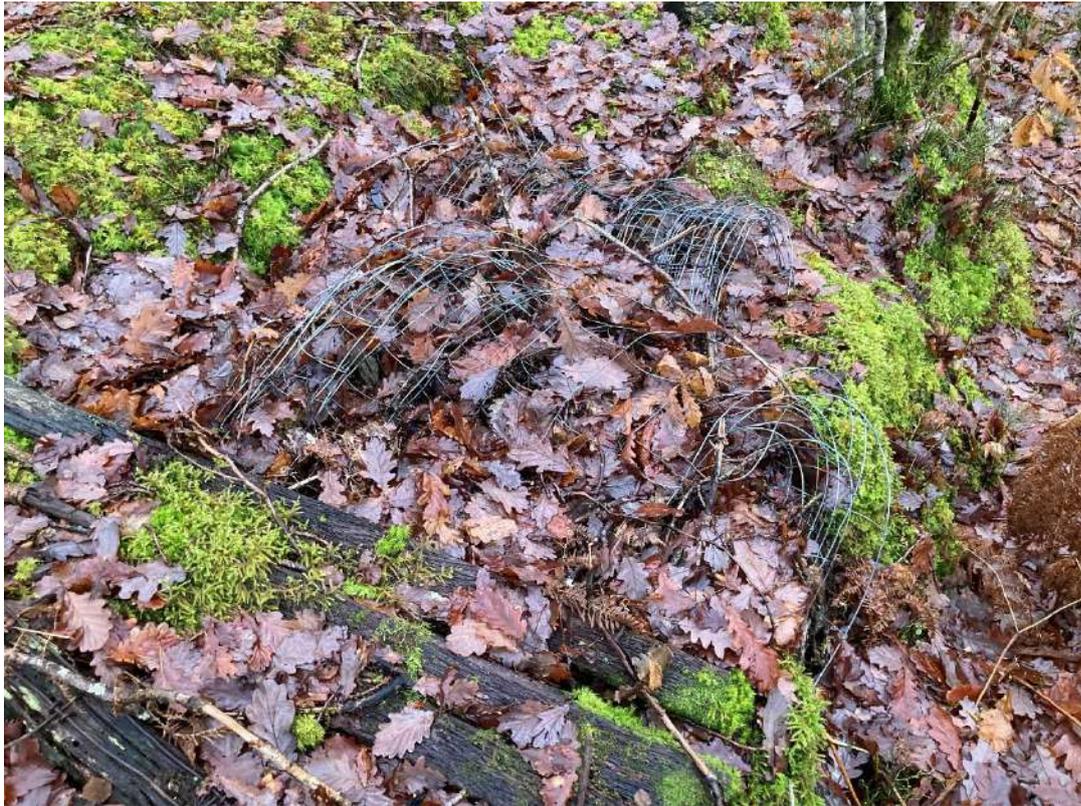
Note that the remains of the old fence along the roadside boundary have been left within the woodland and ideally these should be removed from site and taken to a registered tip to allow the scrap metal to be recycled. There would be a small cost involved in this and it is suggested the vendor deal with this issue.

Parts of removed fence left on site

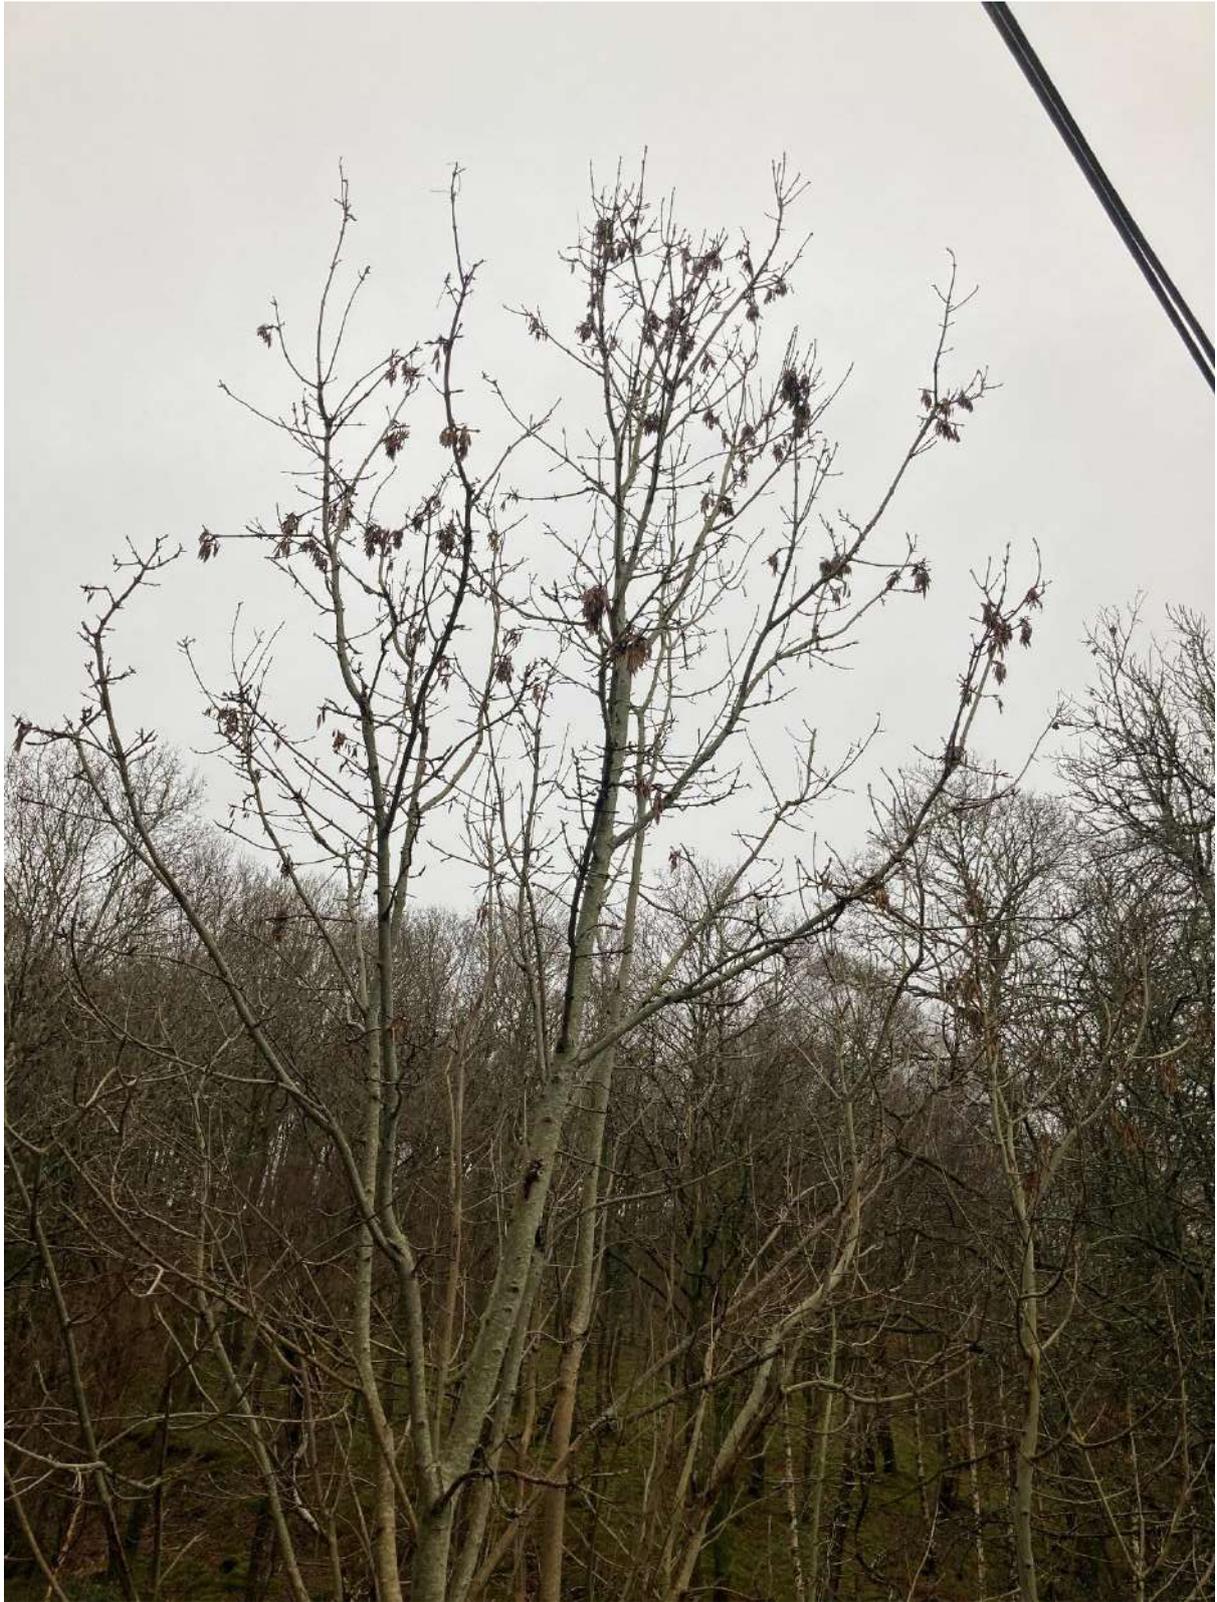
There is a small percentage of Ash in the crop mainly natural regeneration which is showing signs of Chalara Fraxinea or Ash Dieback which is significant issue regarding ash nationally but due to the low proportion of ash in the crop this is not a threat to the overall woodland.

Ash regeneration showing signs of ash dieback
